NACRA **Sailing**

This winter we have received reports of 3 front Nacra 17 crossbars that where buckled. Two were sent to our Headquarters for inspection.

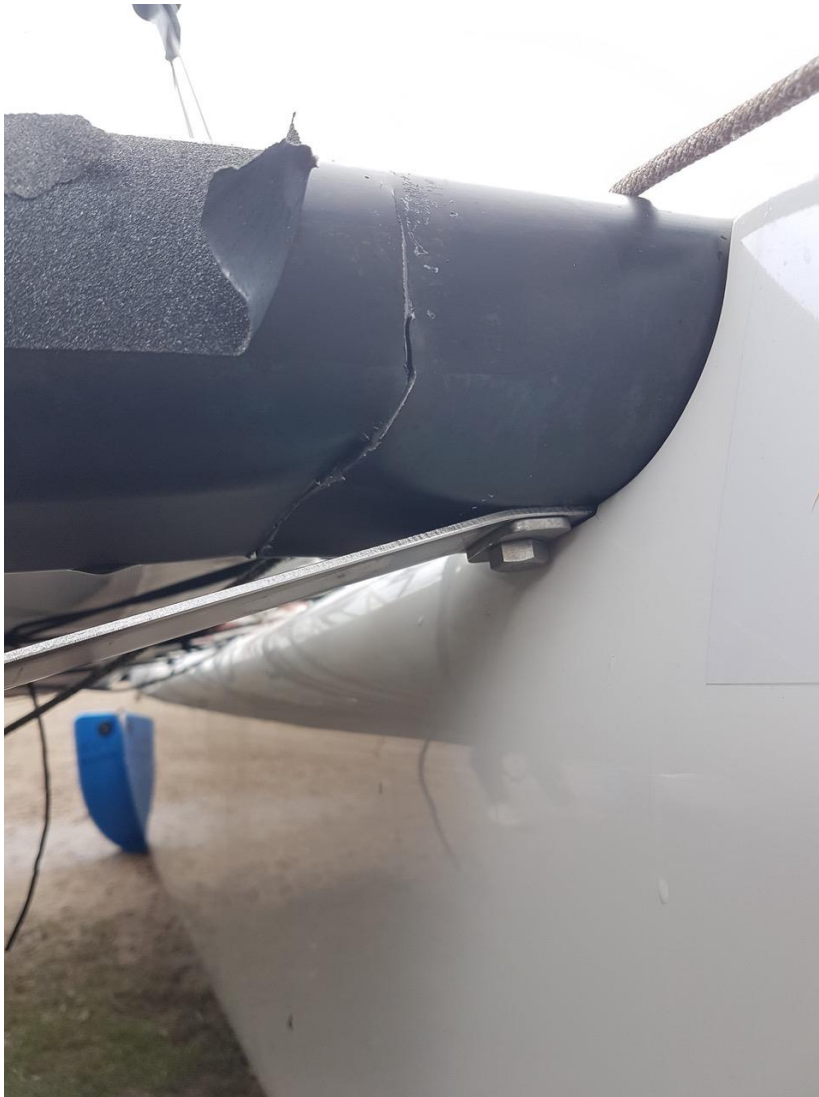
Picture below: of “buckled” front crossbar.

- No indication of problems with aluminium front crossbar extrusion, wall thickness or construction
- Inspection of the dolphin striker rod learns that these “Front crossbars” where overbend, this was visible after examination of the used “Stainless steel thread” cut on the dolphin striker rod. Fact: One of these front crossbars came in and showed a setting of 19 mm!!
- These settings found are in direct conflict with the provided Nacra assembly manual settings.
- The Nacra assembly manual & Nacra 15 class and Nacra 17 class rules are conflicting on this particular issue.

- The earlier mentioned 3-front Nacra 17 crossbars have “buckled” by tightening extreme bending, resulting in failure by not following/respecting the maximum settings as provided in the Nacra assembly manual.
- The teams that provided us with the evidence of these front crossbars have received new ones to replace their old ones. The reason that we have replaced these crossbars without costs has to do with the fact that the Nacra class rules are in conflict over the settings with the Nacra assembly manual.
- These 3 teams will reuse all other parts of their old front crossbar and rebuild these themselves.
- Nacra Sailing have advised the Nacra 17 and Nacra 15 class, to update the current class rules to a minimum and maximum beam setting (see below)

- Nacra customers will be informed about the risk of overbending their front crossbar and that they need to follow the Nacra assembly manual settings and not the current Nacra 15 and Nacra 17 class rule settings

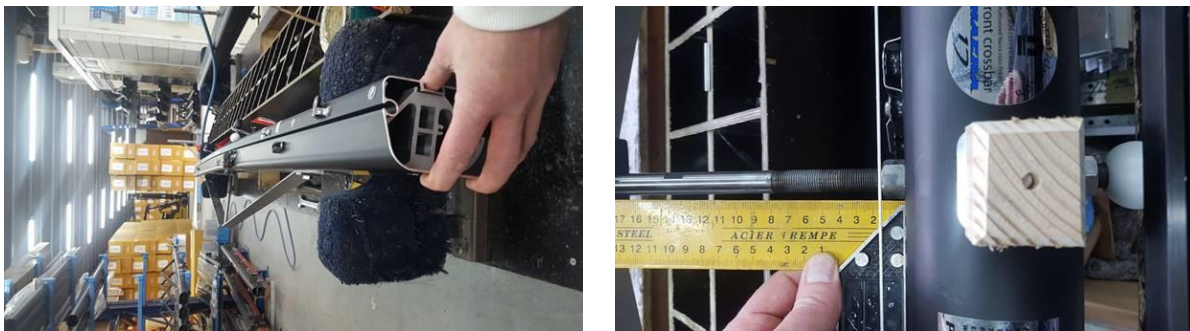
Picture below: Showing setting of front crossbar to max class rule setting (15 mm)

Minimum	Maximum
Front cross beam curvature	0mm	15mm

Front cross beam curvature is the greatest distance between:

the cross beam

and a straight line from the port and starboard bottom points of the beam at the intersection with the hull

taken at 90° to the straight line with the dolphin-striker tensioned, the mast removed, the cross beam horizontal and both crossbeams tightened into their beam beddings.

Minimum	Maximum
Front cross beam curvature	5 mm	9 mm

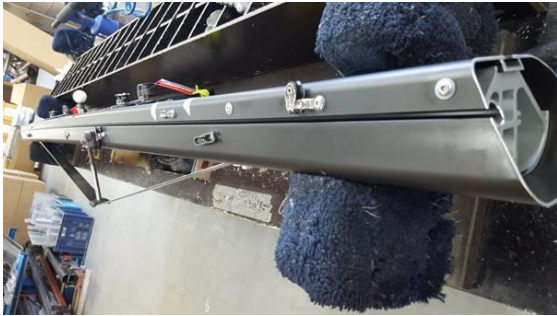
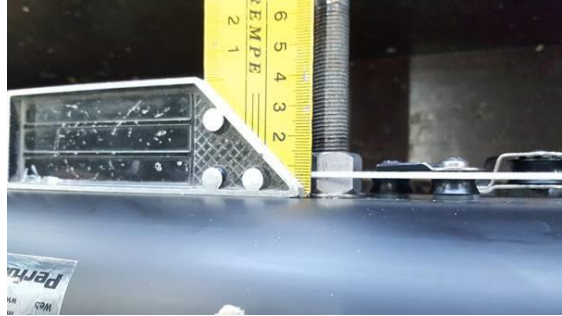
1.2 FRONT CROSSBAR PRE-BEND

Pictures below are from a front crossbar being pre-bended following the Nacra assembly manual instructions.

- There should always be a pre-bend on the front crossbar. This is been achieved by the tension on the dolphinstriker.
- On **new** beams the tension on the dolphinstriker must be reset after: -2 hours of sailing and -10 hours of sailing!

1. Release the tension on the nut located on top.
2. Release the tension on the nut located under the crossbar
3. Put grease on both nuts!
4. Measure **15mm** from top crossbar to underside nut

4. screw the nut under the crossbar until both nuts are tightend.

When the mastpin starts to twist, fixade it with the pump plier wrench. Protect the mastpin from wearing!
